# **Resolution of Damaged Metallization on Highly Complex Semiconductor Device**

<sup>1</sup>*New Product Development and Introduction, STMicroelectronics, Inc., Calamba City, Laguna, 4027, Philippines.*

The paper focused on the resolution of damaged metallization during assembly process that lead to gross open-short (O/S) rejections during functional testing of a highly complex semiconductor package. Numerous batches were put on hold due to not meeting the specification assigned for the short contact test. Design of experiments (DOE) on assembly processes were conducted and eventually identified the reject as an electrostatic discharge (ESD) related failure. Corrective actions and ESD controls significantly reduced the occurrence of damaged metallization with around 85% reduction.

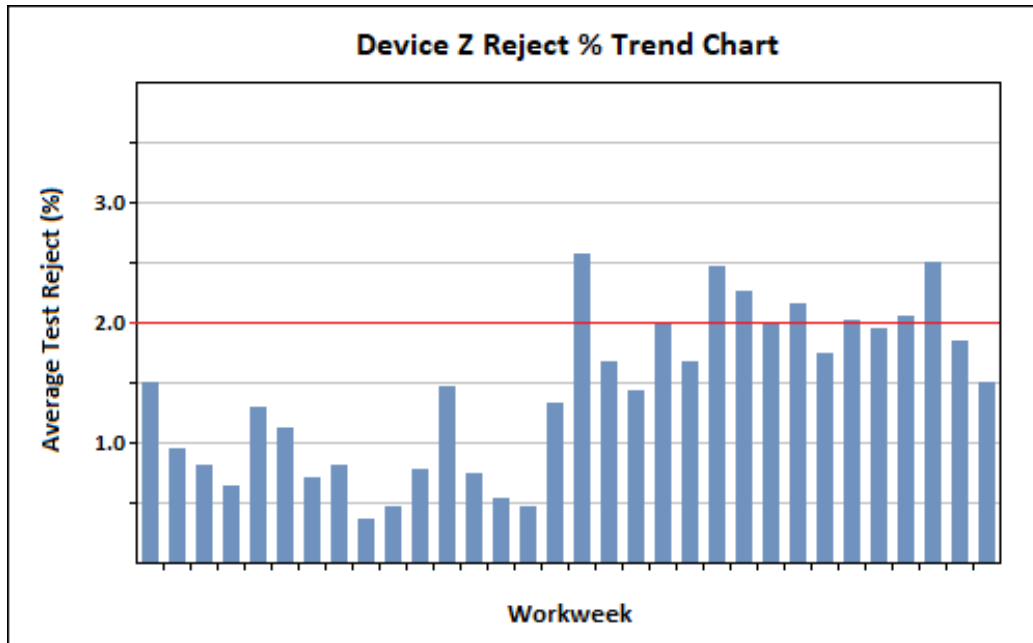
Fig. 1. Test reject percentage weekly performance

process batches were put on-hold due to not meeting the 2% final test disposition criteria. Batches having test rejects > 2% were noticed on a span of several weeks as illustrated in Fig. 1.

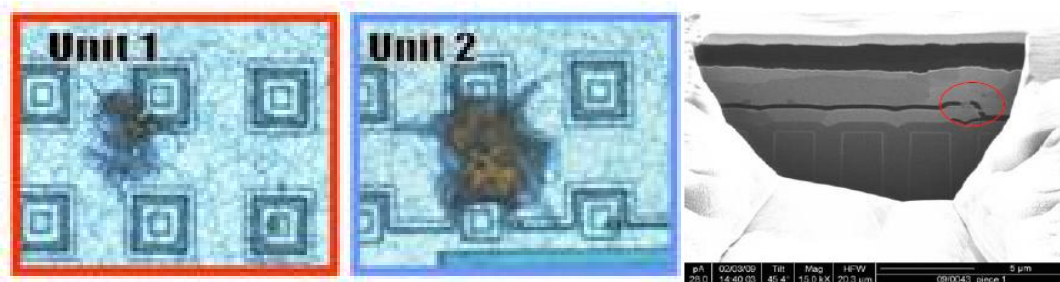
Fig. 2. Damaged metallization manifestation

Analysis of test failure revealed that the major contributor to the rejection is the damaged metallization of the silicon die. Fig. 2 shows the investigation of test reject samples.

It was also noticed that a gold deposit was present along the location of damaged metallization. Cross-sectional analysis on the identified area revealed that an internal damage was seen on the passivation of the die. Two

instances were normally observed when damaged metallization is seen on the passivation: 1) Gold deposition on the location of damage metallization; 2) Shorting of two metal layers which is only seen during cross-section of reject sample.

ESD was identified as one potential cause for damaged metallization that resulted to test reject. The damage manifestation seemed to be induced by ESD due to explosion effect on the part of the damaged metal as previously shown in Fig. 2. With this, ESD controls were checked particularly the ionizer setup as improved in Fig. 5.

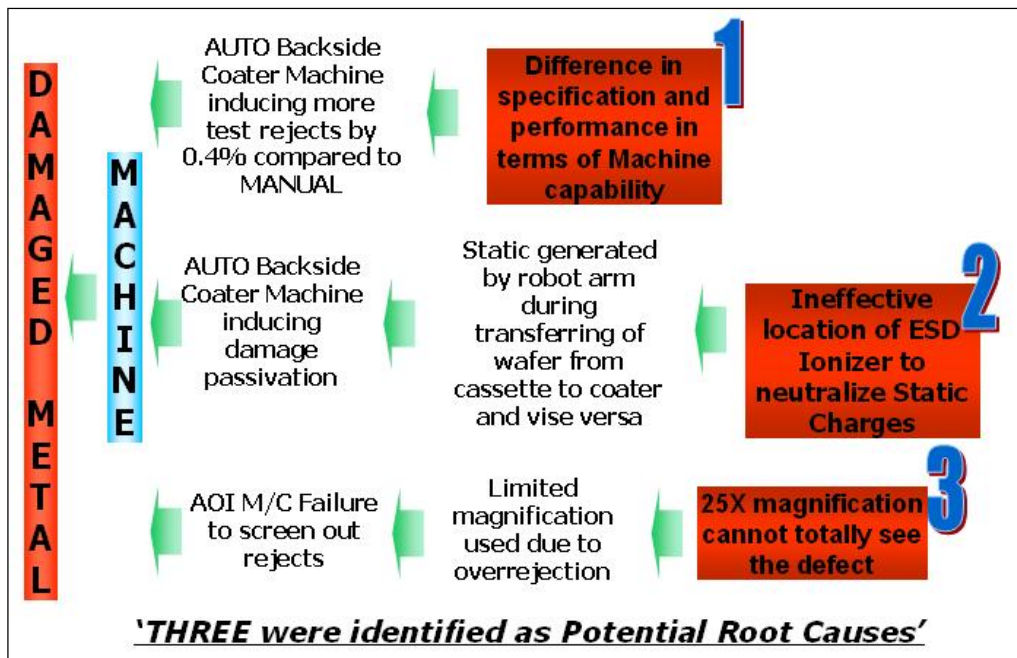
Fig. 4. Fault tree diagram

Cross-functional team was created, and brainstorming was made. A fault tree diagram was established as shared in Fig. 4. Several factors were identified and appeared as potential causes but only three scenarios were considered as the most probable, critical, and significant based on the signature of damage metallization.

1. Machine-to-machine variation (specification and condition)
2. Device sensitivity on ionizer location (electrostatic discharge (ESD) phenomenon)
3. Limitation of inspection criteria

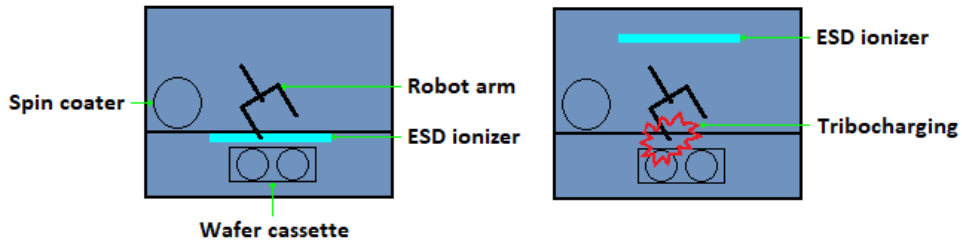
Fig. 5. Before vs after relocation of ionizer

Spin coating has the highest level of ESD. Measured field voltage level is around 380V which is much higher to the specification requirement of < 100V. Field voltage was

measured using ESD event detector. The level of ESD measured was high, due to ineffective location of ionizer to neutralize the event. Discussion on the fundamentals of ESD and ESD damage could be found in the ESD Association references [9].

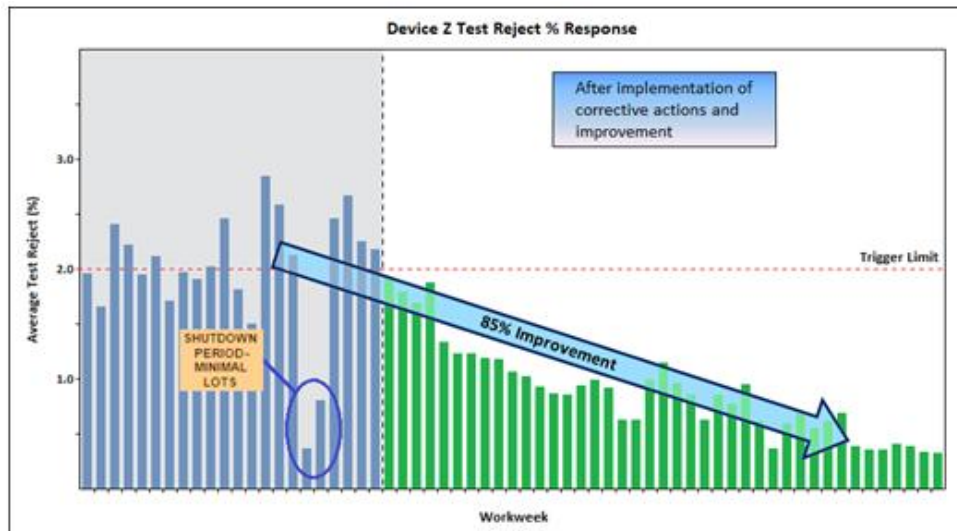
Fig. 6. Test reject performance improvement

Significant effect was achieved in the average test reject per workweek performance after implementation of all improvement and corrective actions. Fig. 6 highlighted around 85% improvement in the test reject reduction caused by damaged metallization. Final test yield trend eventually stabilized after implementation of the identified corrective actions.
