# **Resolution of Damaged Metallization on Highly Complex Semiconductor Device**

<sup>1</sup>*New Product Development and Introduction, STMicroelectronics, Inc., Calamba City, Laguna, 4027, Philippines.*

The paper focused on the resolution of damaged metallization during assembly process that lead to gross open-short (O/S) rejections during functional testing of a highly complex semiconductor package. Numerous batches were put on hold due to not meeting the specification assigned for the short contact test. Design of experiments (DOE) on assembly processes were conducted and eventually identified the reject as an electrostatic discharge (ESD) related failure. Corrective actions and ESD controls significantly reduced the occurrence of damaged metallization with around 85% reduction.

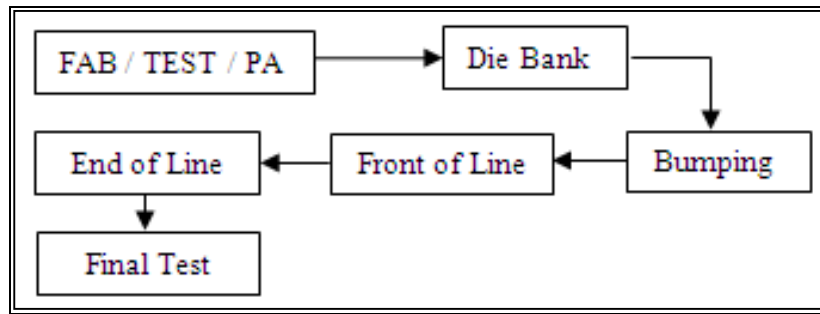
Fig. 3. Process macro map

A complete process flow is given in Fig. 3, starting from silicon die fab going to pre-assembly (PA) until final test. Important to note that generally, process flow varies with the product and the technology [5-8]. Results of design of experiments (DOE) regarding process mapping show that damaged metallization would most likely to occur on pre-assembly and bumping station. This was identified after sending DOE failing parts for further failure analysis.

Investigation revealed that gold deposits were present along the damaged metallization and the potential process that may cause the problem is the bumping process. Special remark is that bumping station uses gold deposition on its process.
